# Flexco® Cracking Chisel

With the Flexco® Cracking Chisel, excessively worn top plates and individual fasteners can be replaced quickly and easily. Only a hammer and a Flexco® Cracking Chisel are required. Removal of prematurely worn plates avoids installing a complete new splice. Saves time and money. Two simple steps.

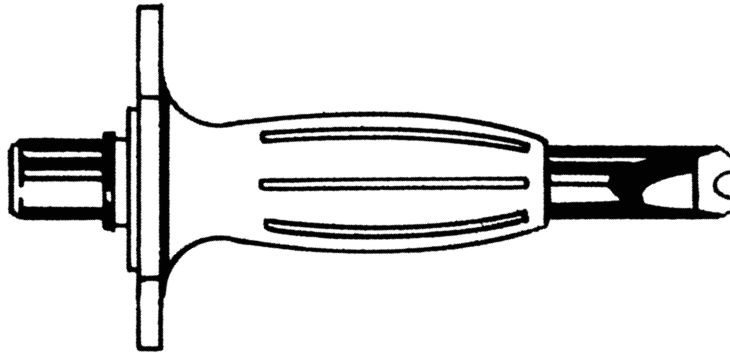
- Replacement of prematurely worn plates in minutes without replacing entire splice.
- Requires only a hammer.
- Three sizes available.  
C1C for No. 1, 140 or 190 nuts  
C2C for No. 1-1/2, 2 or 2-1/4 nuts.  
C3C for No. 2-1/2 and 3 nuts

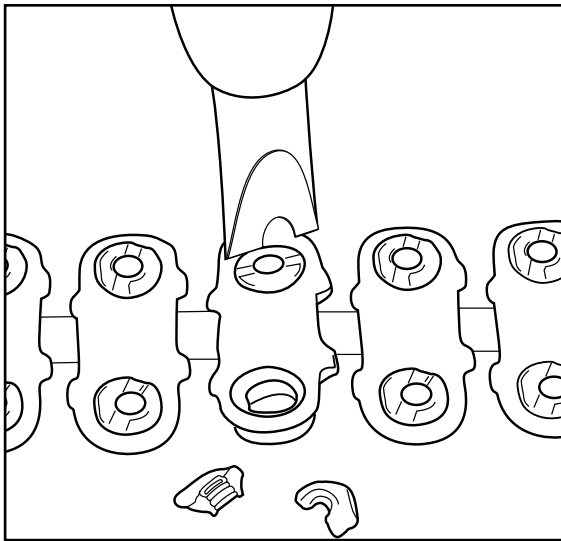
1. Place Cracking Chisel over the nut and hit with a firm blow. Use a 2 lb. or heavier hammer. Be sure to wear safety goggles. **NOTE:** Position worn plate over solid backing before striking chisel.

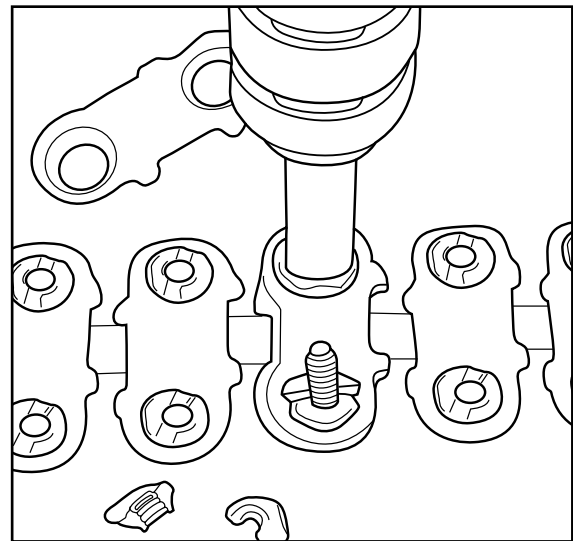
2. After nuts are removed, replace plates, bolts, and nuts. Tighten nuts and break off excessive bolt ends. **NOTE:** Tighten nuts so plates compress into belt cover and pucker belt around plate edge.
